Operation
REDWING

Project 1

THERMAL AND BLANKET EFFECTIVENESS TESTS
B-47 AIRCRAFT IN PACIFIC

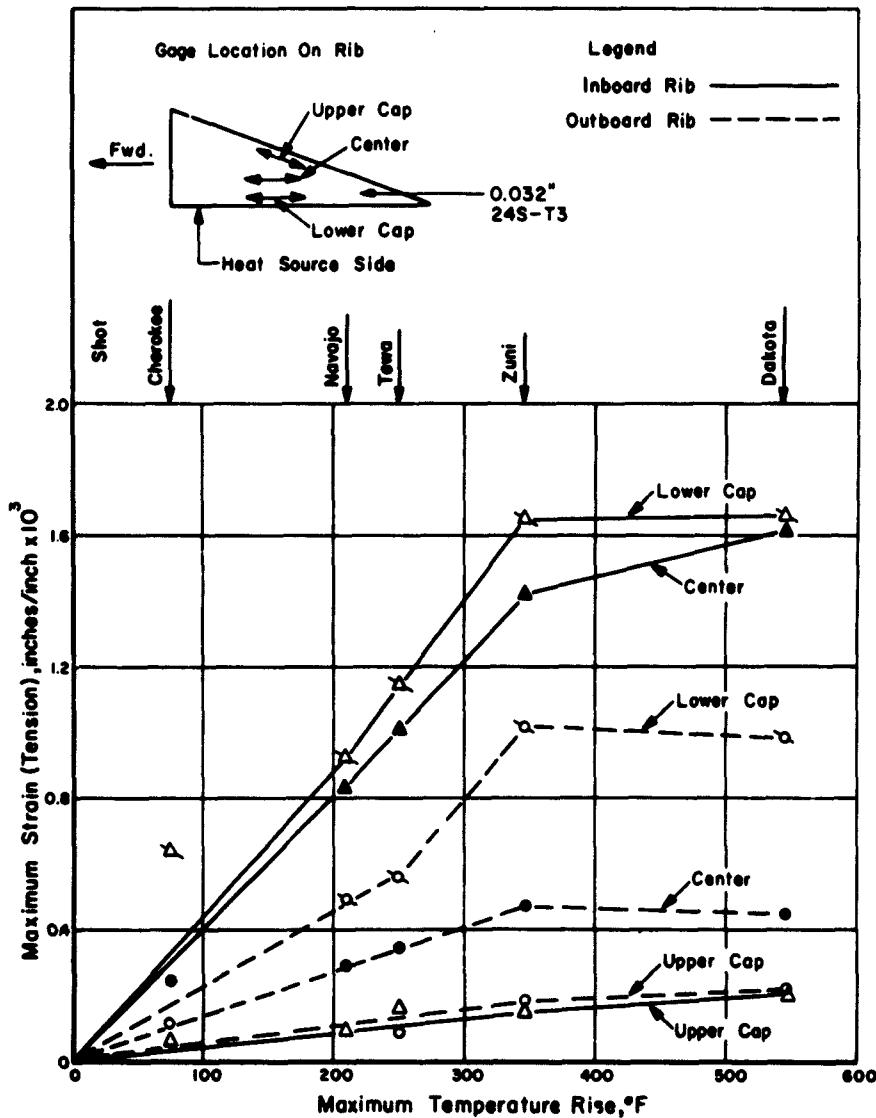
Tables 4.5 and 4.6. Peak values of stress-producing strain in the left elevator ribs have been compared with maximum lower-skin temperature rise (Figure 4.7). Since the tension applied to the rib by the heated, expanding skin changed abruptly in the skin-temperature range of 350 to 450 F, this comparison of rib strain versus skin temperature indicated that yield of the skin had

apparently occurred. Hence, there was little change in rib strain at higher skin temperatures. This also provided evidence that failure of skin occurred before failure of the primary structure.

Figure 4.7 Relative rib strains versus maximum lower skin temperature rise.

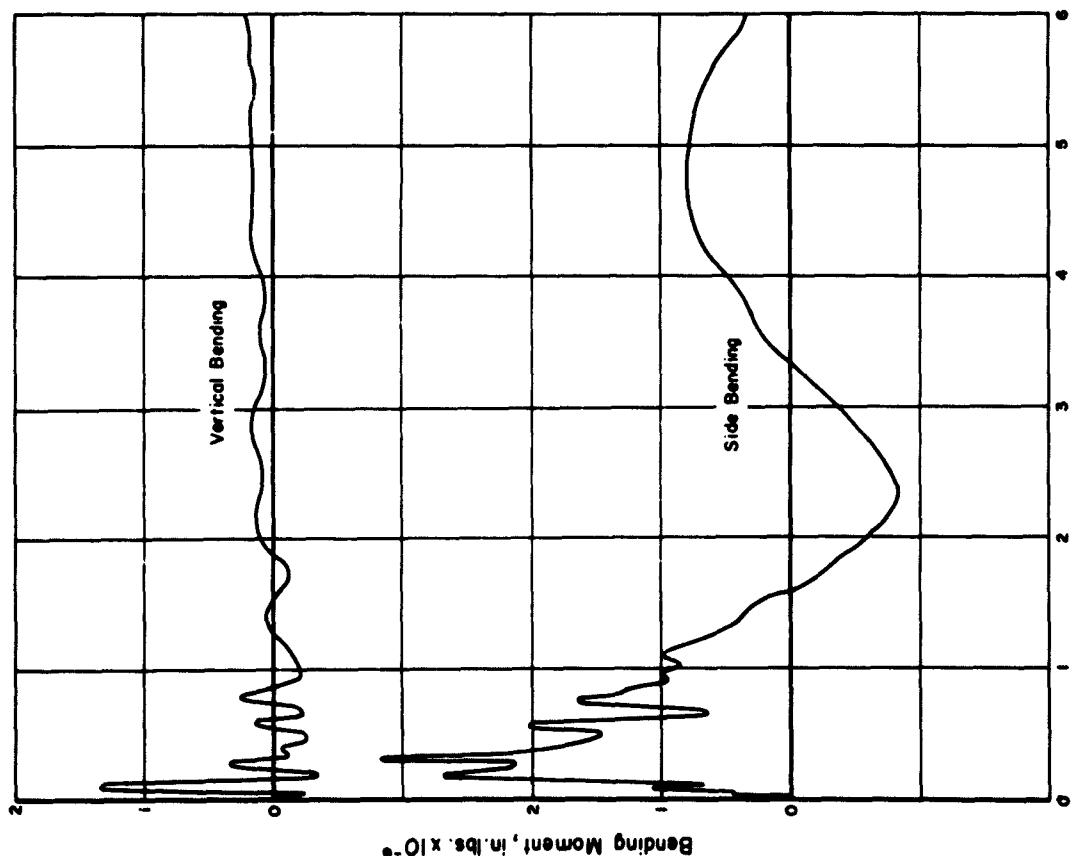
Figure 4.16 Time-history representation of differential bending moment taken at Fuselage Station 1044.0 during Shot Huron.

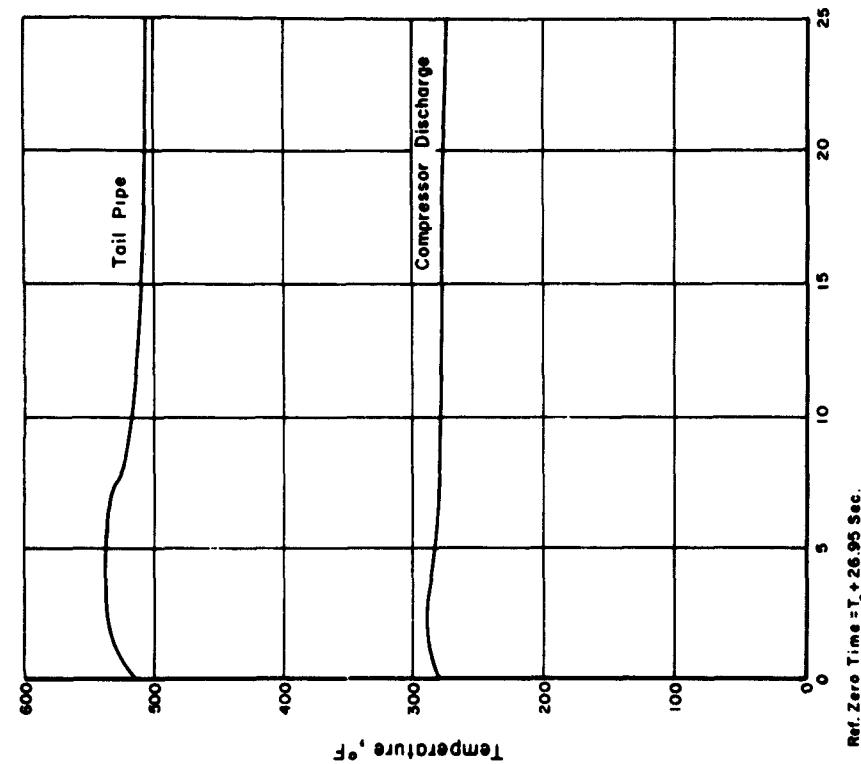
Figure 4.19 Time-history representation of engine temperature taken during Shot Dakota.

4.5.3 Effects on Engine Performance. Data listed in Table 4.12 were obtained from pressure transducers and thermocouples installed directly on the engine and recorded in the CRA, with the exception of engine rpm, which was indicated directly on the chaff chute photo panel. Time-history graphs of engine performance for Shot Dakota appear in Figures 4.18 and 4.19.

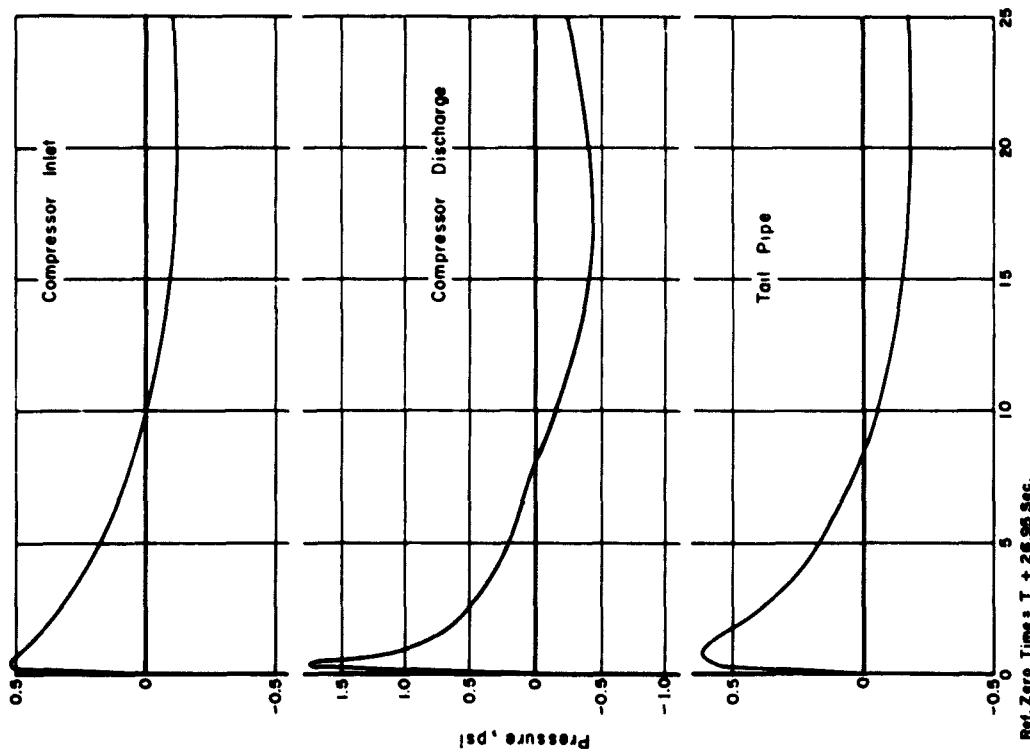
Figure 4.18 Time-history representation of differential engine pressure taken during Shot Dakota.

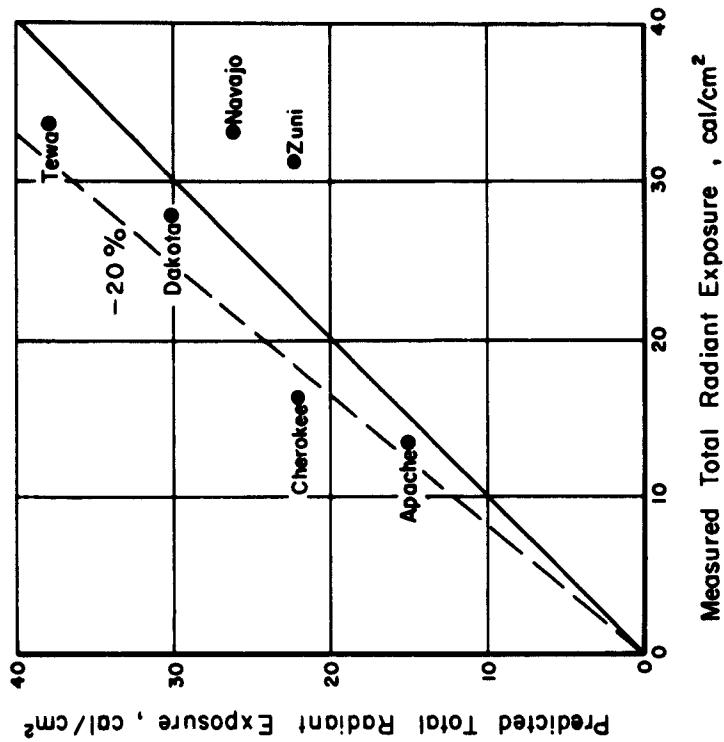
Predictions of total radiant exposure were found to be generally conservative; i. e., higher than actual radiant exposure as measured by the calorimeters. This conservative trend is evident in Figures 5.1 and 5.2 where the data can be seen to lie, in general, closer to the 20 percent line than to the perfect agreement line. Measured total radiant exposure was based upon the readings of three calorimeters aimed at ground zero, equipped with quartz filters and possessing 90-degree fields of view.

In both Figure 5.1 and Figure 5.2, Shots Navajo and Zuni show unusually high measured values in comparison with the predicted, while in both cases the measured values which were lowest with respect to predicted were recorded on Shots Cherokee and Tewa. The meteorological data of Table 4.2 indicate a possible reason for this occurrence. During all shots, the heaviest cloud coverage at altitudes between the device and the aircraft was reported for Shots Navajo and Zuni and the lightest for Shots Cherokee and Tewa.

Figure 5.2 Predicted versus measured total radiant exposure direct from ground zero.

It seems likely, then, that the prediction trend was 20 percent or more conservative, and that the heavy cloud coverage on Shots Navajo and Zuni caused an unpredicted increase in measured thermal energy.

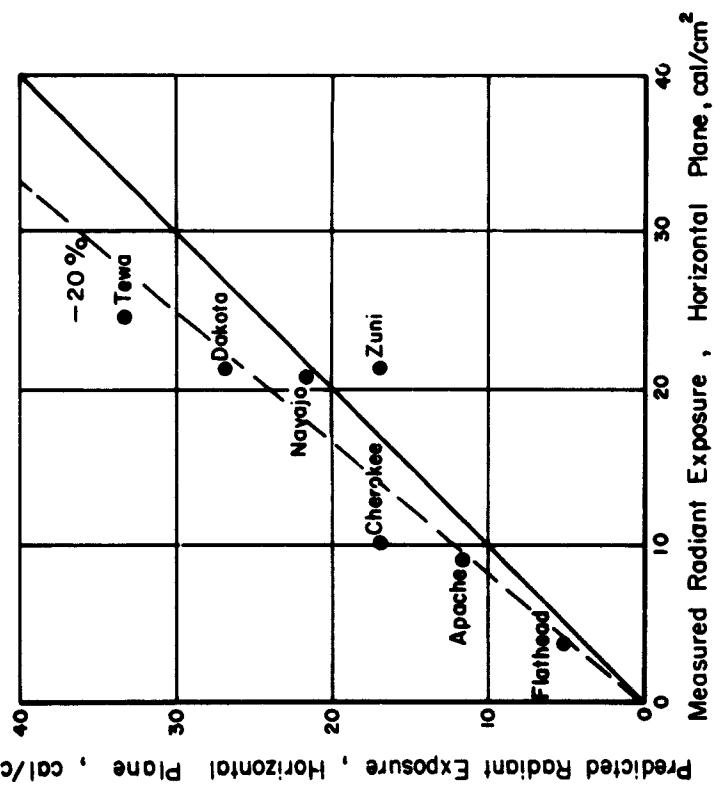
Figure 5.1 Predicted versus measured radiant exposure incident upon a horizontal plane.

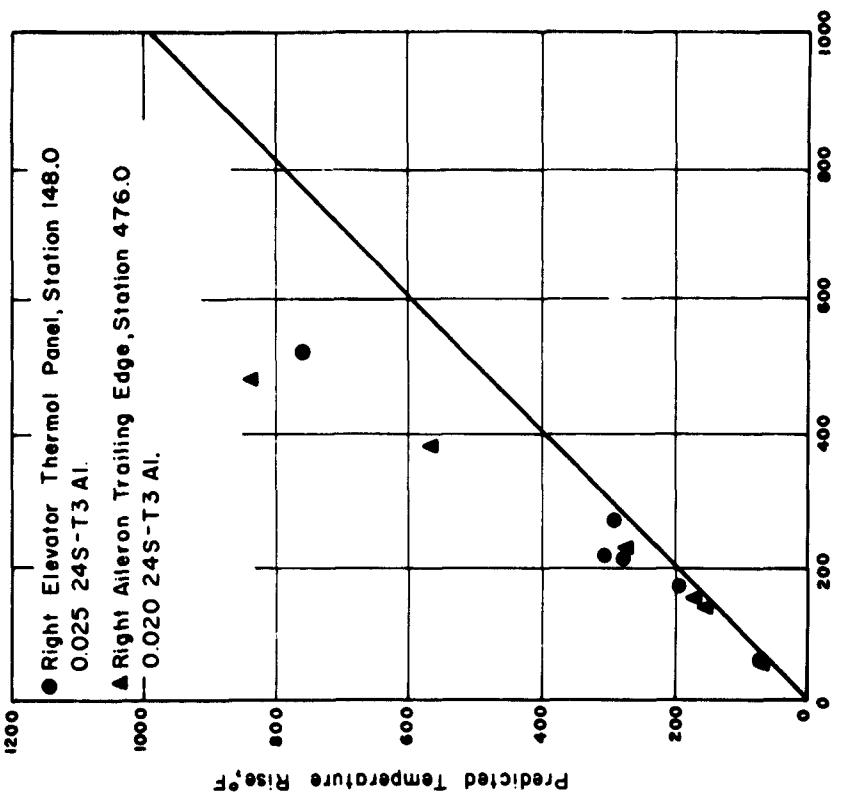
5.2.1 Temperature Rises. Measured temperature rises in the lower center panel of the right elevator have been compared to predicted values in Figure 5.4. The predicted temperature rises are based upon measured thermal radiation at the surface. The theoretical rises are seen to be higher than measured rises, showing conservatism in the prediction theory.

Figure 5.4 Predicted versus measured temperature rise.

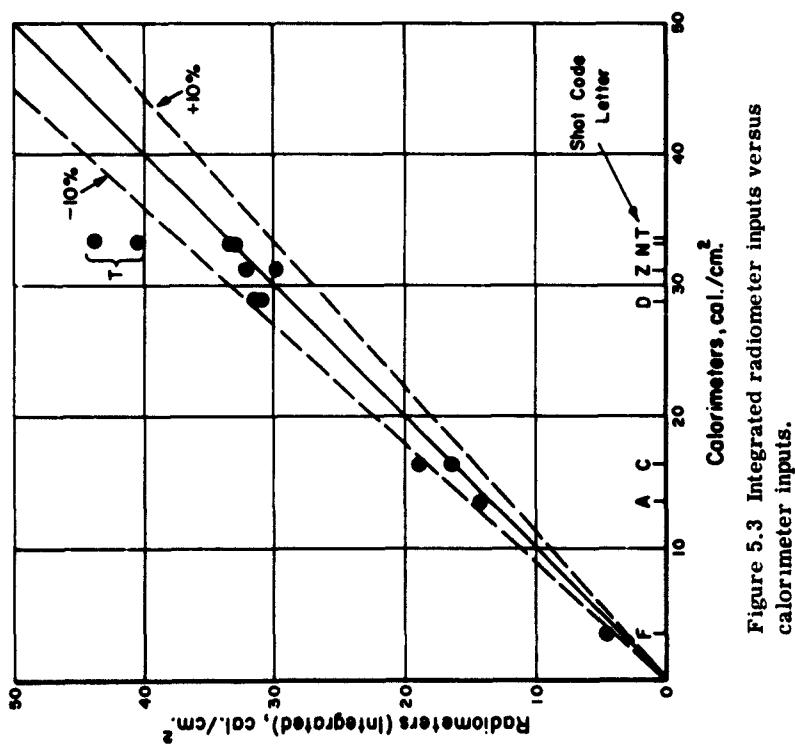
The reliability of measured values of irradiance and radiant exposure can be estimated by integration of the thermal irradiance curve to a time where further integration would not add significantly to the total value. At that particular time, a comparison was made of measured radiant exposure and the integrated irradiance. The comparison is shown in Figure 5.3, and good correlation is evident.

Figure 5.3 Integrated radiometer inputs versus calorimeter inputs.

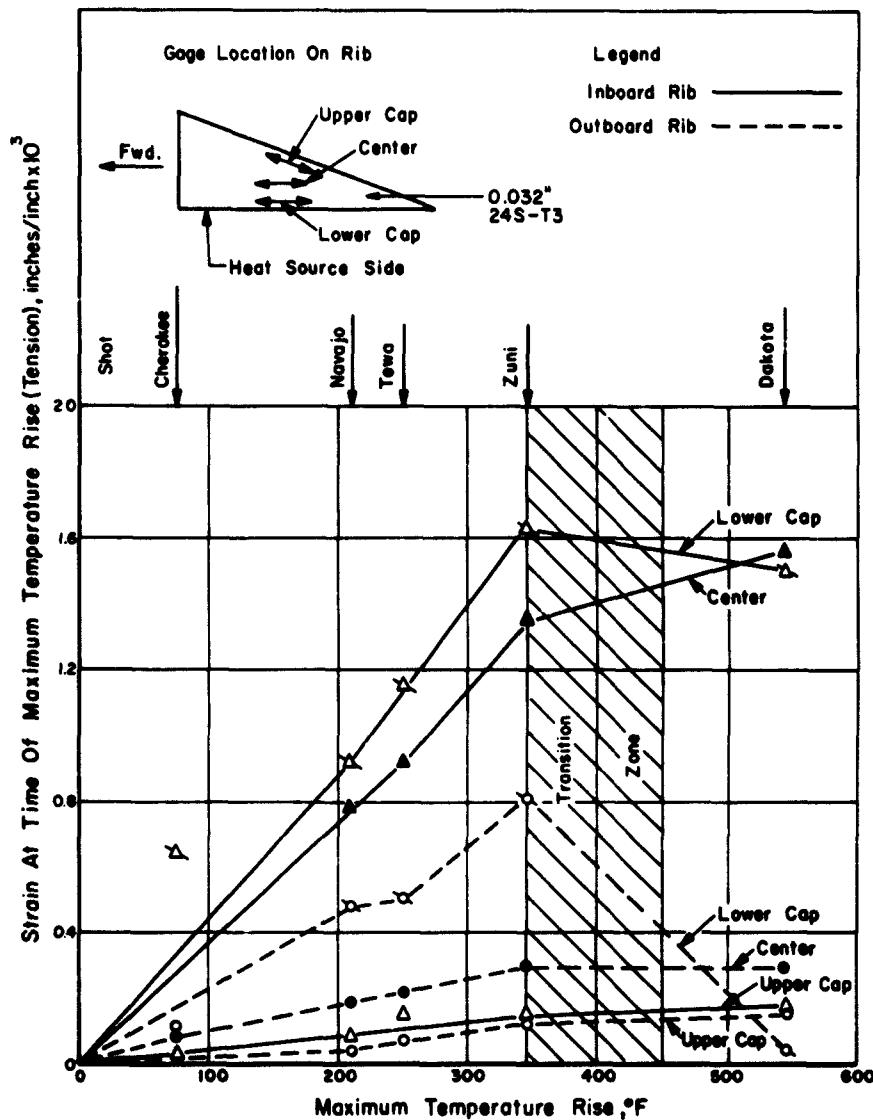
Because of the existence of lightening holes in the outboard rib of the left elevator, the mass is less than that of the inboard rib. Because of this mass difference, the temperature rise for the outboard rib is always larger and more rapid than for similar points on the inboard rib.

This causes the outboard rib to exhibit temperature reactions more similar to the lower skin surface than does the inboard rib; thus, the stress-producing strains in the inboard rib are always greater for similar points when compared to the outboard rib as shown in Figures 4.7 and 5.5.

Figure 5.5 Related rib strains of the left elevator thermal panel.

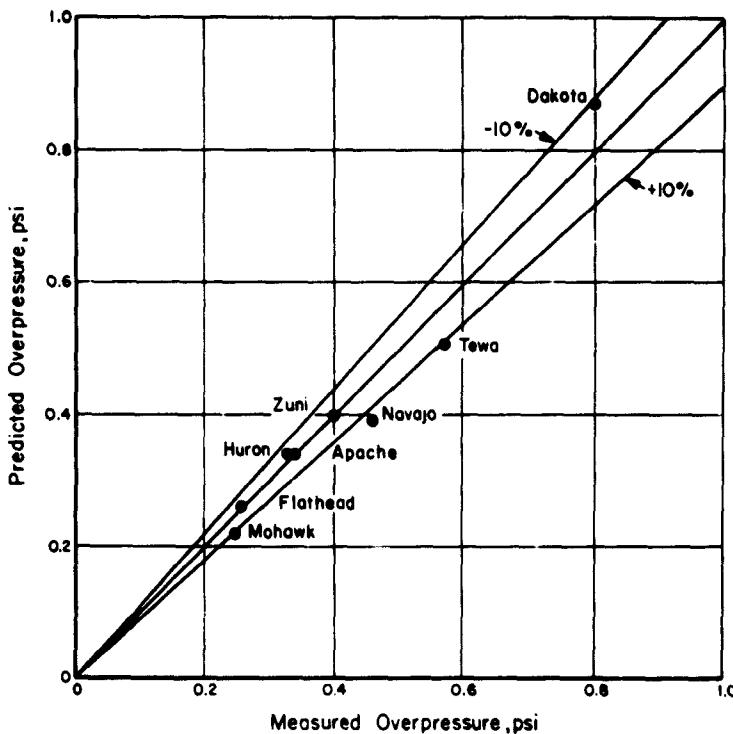
As shown in Table 4.8, peak overpressures measured on the aircraft fuselage ranged from 0.25 to 0.80 psi. The correlation of measured and final postshot predicted overpressures is shown in Figure 5.6. The predicted values were based on final measured yield and aircraft position. Data from all shots indicated that the theoretical method of predicting overpressure was

accurate to within approximately 10 percent. The data shown in Figure 5.6 were measured at a point tangential to the direction of shock propagation to eliminate as much as possible the effect of dynamic pressure and air-flow disturbances. A comparison of the pressure measured tangential to the impinging shock front and pressure measured on the bottom fuselage is shown in Figure 5.7 to illustrate the effect of dynamic pressure.

Figure 5.6 Predicted versus measured overpressure.

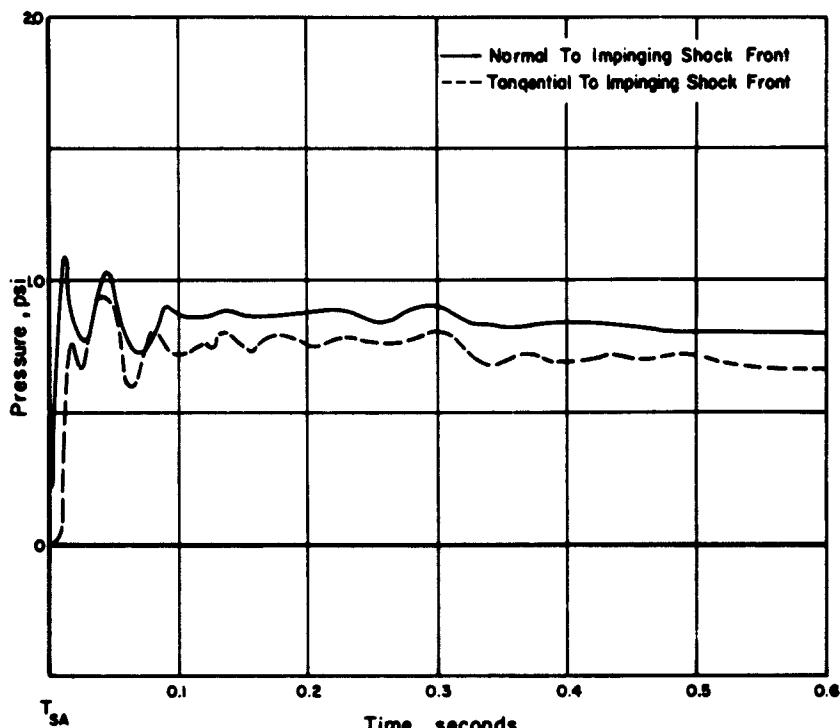
Figure 5.7 Comparison of differential pressures taken at points tangential and normal to the impinging shock front.

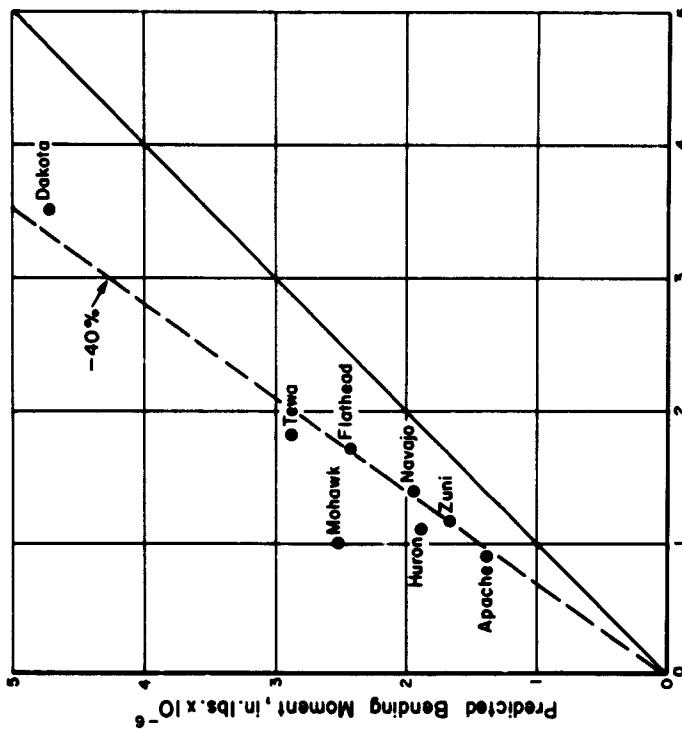
5.4.2 Structural Response. In order to establish primary aircraft capabilities, the structural reactions of the wing due to gust effects were measured and compared to predicted reactions, based on existing theories using final yield and aircraft position. Comparisons of wing bending at Wing Stations 615.0 and 493.0 showing the correlation between measured and predicted values, are given in Figures 5.8 and 5.9. The coordinates are the incremental wing-bending increases from the 1.0 g flight conditions. The comparisons for Wing Station 615.0 show theory to be un-

Figure 5.9 Predicted versus measured bending moment
at Left Wing Station 493.0.

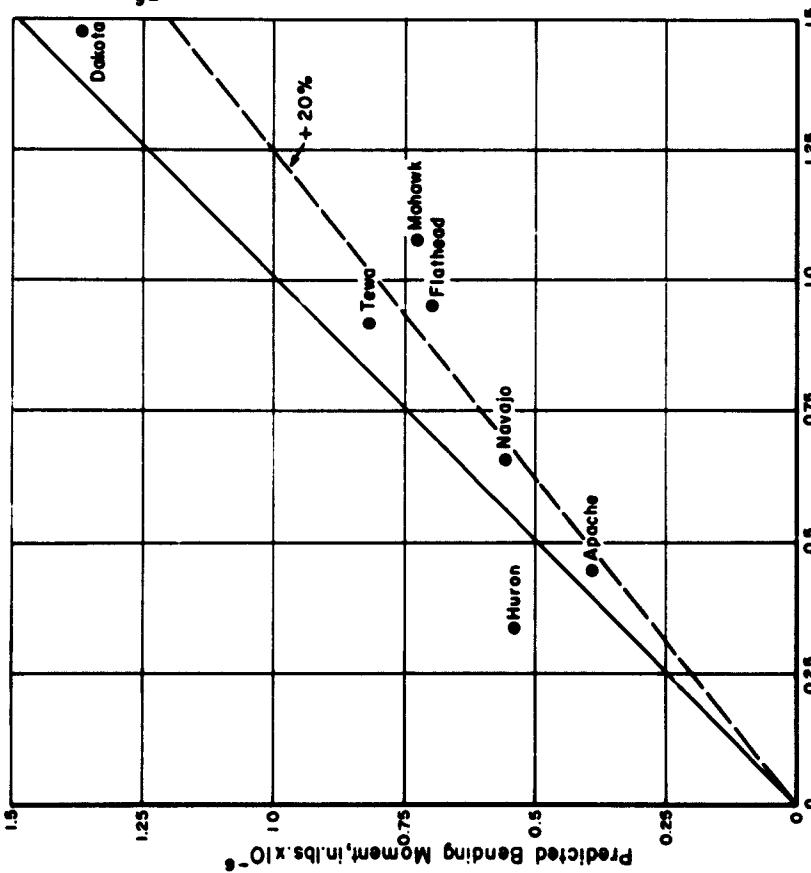
Figure 5.8 Predicted versus measured bending moment
at Right Wing Station 615.0.

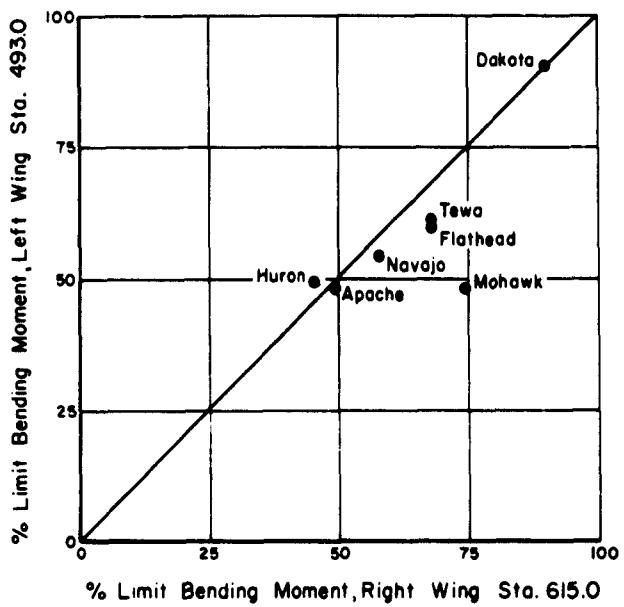
A plot of percent limit bending moment at Wing Station 615.0 versus percent limit bending moment at Wing Station 493.0 (Figure 5.10) indicates that in all but two events, Shots Huron and Dakota, Wing Station 615.0 appeared to be more nearly critical.

Figure 5.10 Comparison of the percent limit bending moments of Wing Stations 615.0 and 493.0.
